STRUCTURES NOTE 469

DISENGAGEMENT OF SAFETY HARNESS BUCKLES
-CT4

DISENGAGEMENT OF SAFETY HARNESS BUCKLES —CT4

During the crash of a CT4 Airtrainer in August, 1979 both safety harness buckles disengaged.

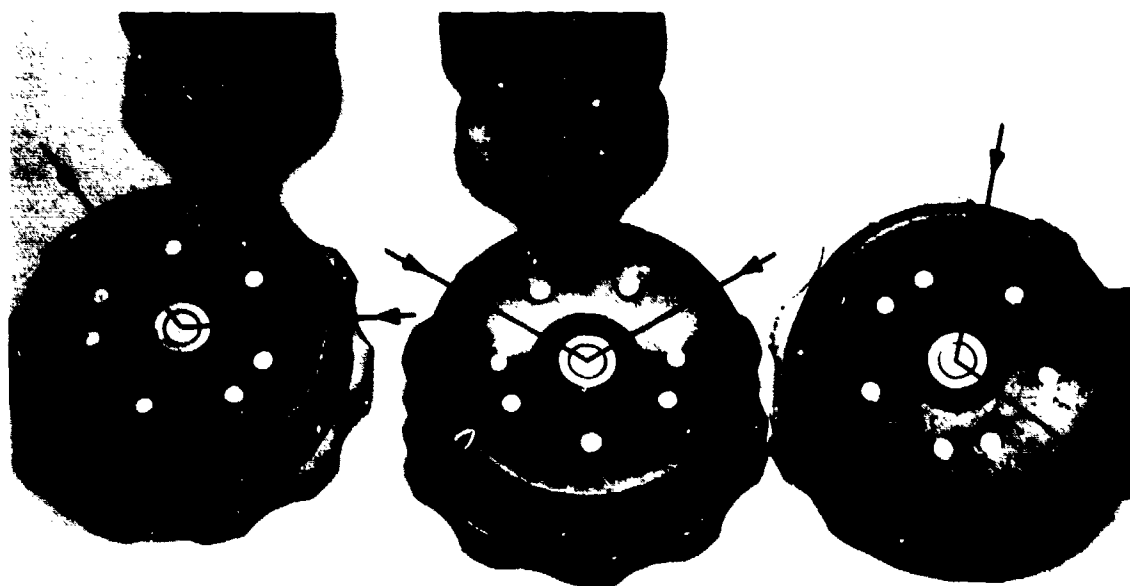
The backs of both buckles were dished as shown on Figure 1a. The deflection was greatest at the sides adjacent to the lap strap tongues as shown in Figure 1b. This figure also shows the flat back of a new buckle. The slots for the tongues were enlarged and some of the rivets which connect the front and back together were elongated. The distortion of the back suggested that the outer ends of the lap strap tongues had been pulled backwards and had prized the front and back of the buckle apart.

FIG. 1(b) THE BACKS OF A NEW BUCKLE AND THE BUCKLES FROM THE CRASHED AIRCRAFT SHOWING 'DISHING'. POSITIONS FOR THE LAP STRAP TONGUES ARE ARROWED.

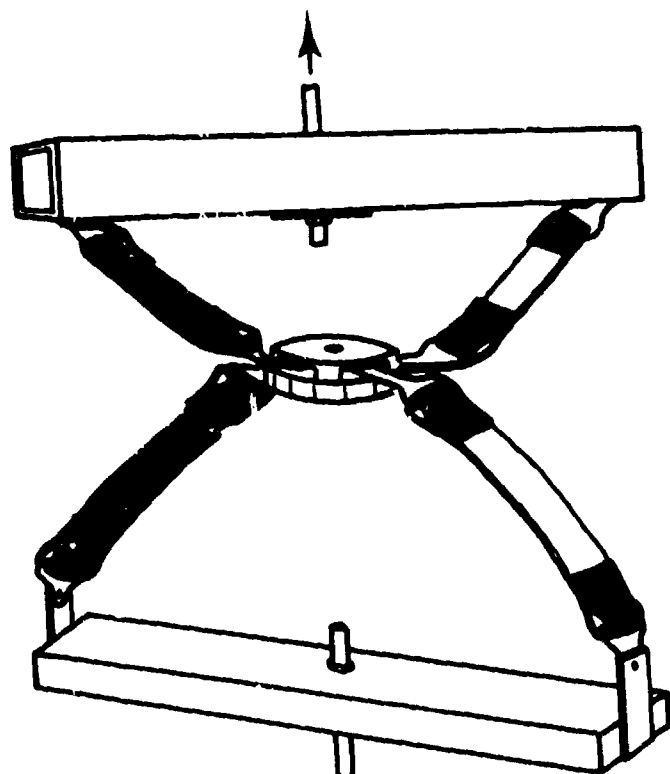
FIG. 13 'PULL-BACK'
TEST B

The arrangement is shown in Figure 13. The lap strap caused dishing of the back of the buckle while the tongues of the shoulder and crotch strap pressed against the front plate. This deflected until the load was carried by the release handle and transmitted into the case by tension in the spindle (construction shown on Fig. 2). When the load reached 3 kN the retaining ring sheared off the spindle. The buckle was prised open and the straps disengaged.

The 3 kN load would represent the difference between the forwards and rearward load vectors at the buckle rather than a net body block force and corresponds to the force of 2.4 kN on the buckle in the "Pull-back" test A.

Separation of the retaining ring shows that the tension on the spindle was greater in test B than in the crash although the backs of the buckles from the crashed aircraft show deformation which could be associated with tension in the spindle.

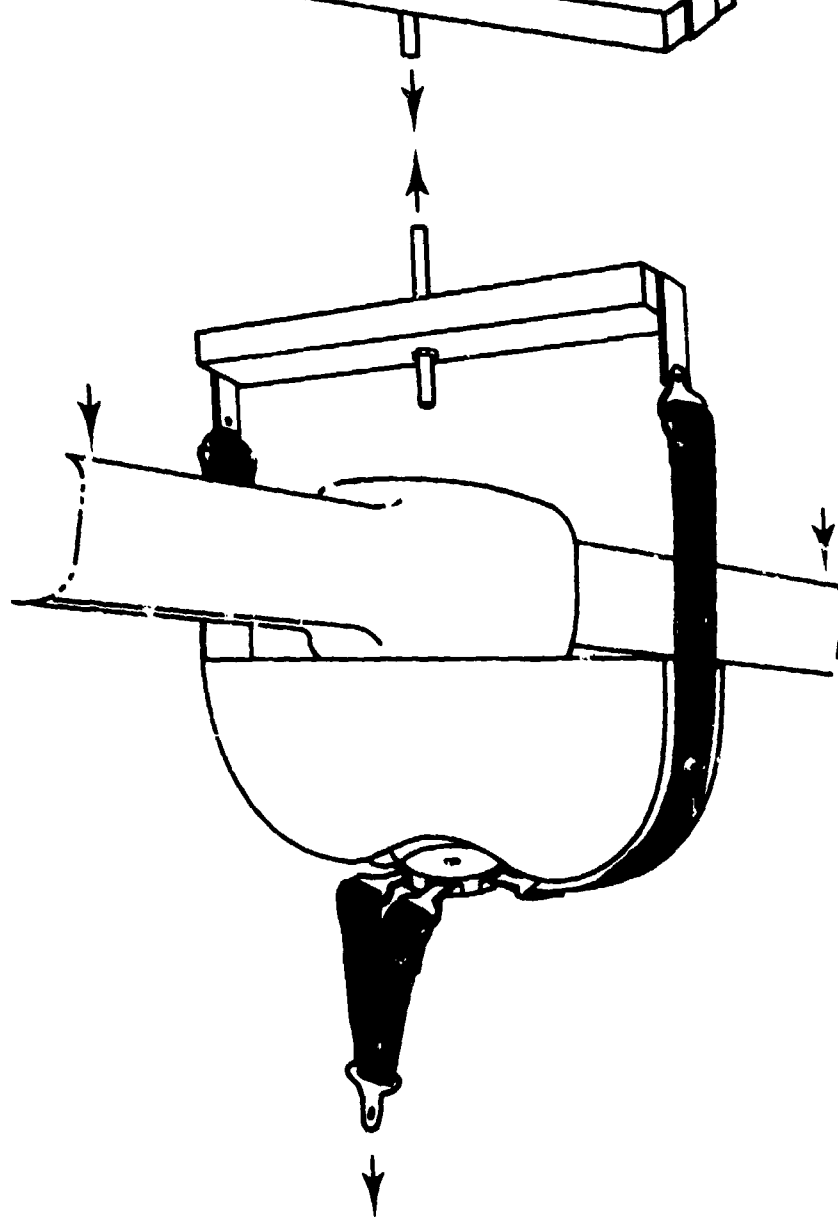
FIG. 14 'PULL-BACK'
TEST C

The loading arrangement is shown in Figure 14. The lap strap was fitted to a body block, which was recessed behind the buckle, and a load of 6 kN was applied to hold the strap tight. Load was then applied progressively to the shoulder strap so that the buckle was twisted by the lap strap tongues. As the load approached 360 N partial withdrawal of the latch pins was evident but then the buckle appeared to "stick". Sticking in this way can be variable and unpredictable so to break the "friction" the crotch strap was jerked by hand, this resulted in separation of the assembly.

The test was qualitative rather than quantitative because the buckle had been used in earlier tests, although it had not previously disengaged, and the jerk force is unknown but the forces were very low in relation to the rated strength of the harness (about 2%).
